## 5.0 AEROELASTICITY

## 5.2 TORSIONAL DIVERGENCE CONSIDERATIONS

### 5.3 FLUTTER ASSESSMENT

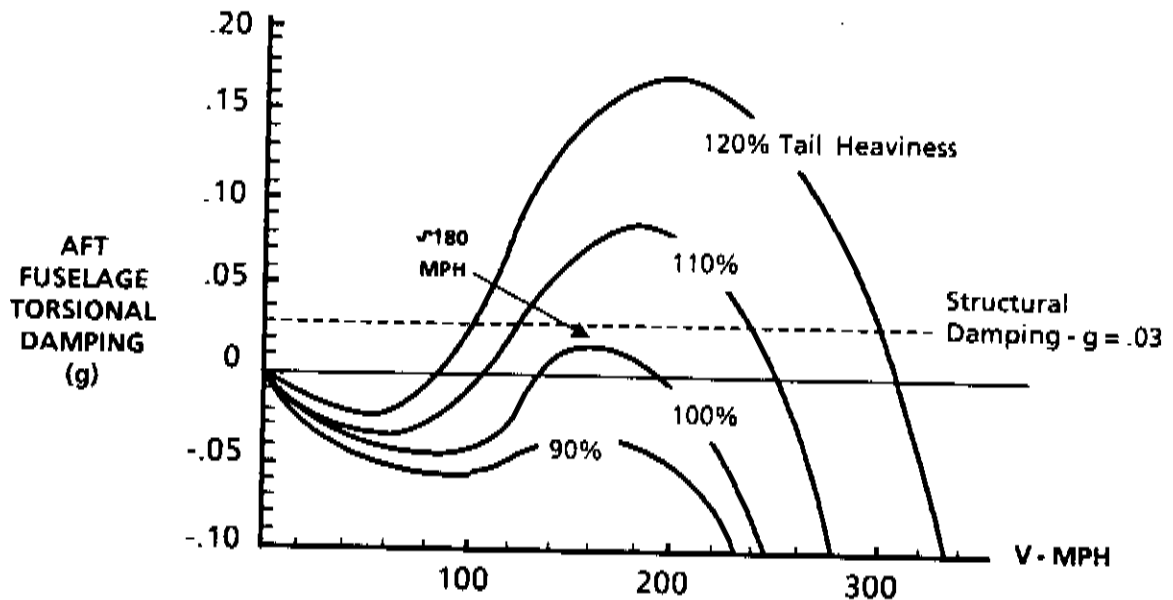
FIGURE 5-1. V-g DIAGRAM FOR THE S35 MODEL FOR VARIOUS DEGREES OF TAIL HEAVINESS (%)

The Model 35 V-g diagram shown in Figure 5-1 indicates that the flutter characteristic at a tail heaviness of 100 percent or more is a hump mode type, i.e., if the structural damping is above the hump, there is no flutter at any speed. The critical structural damping at the hump of 100 percent tail heaviness is about 0.014 at about 180 mph (IAS). However, the analysis based on the V-g diagram cannot provide the information on how much effective damping (a combination of structural and aerodynamic damping) the plane will have at a given flight condition if the structural damping itself exceeds 0.014. There is the possibility that the plane has no flutter instability in the classical sense, i.e., the structural damping is above the hump but its effective value is very small and the structure is susceptible to external excitation such as turbulence. The continuous lightly damped oscillation could distract the pilot and reduce pilot alertness, especially in bad weather conditions.
