6.4 ACCIDENT RECORD FOR MODELS 33 AND 36

6.5 CHARACTERISTICS OF V-TAIL FIFAF ACCIDENTS

7.0 RISK FACTORS FOR IN-FLIGHT AIRFRAME FAILURES

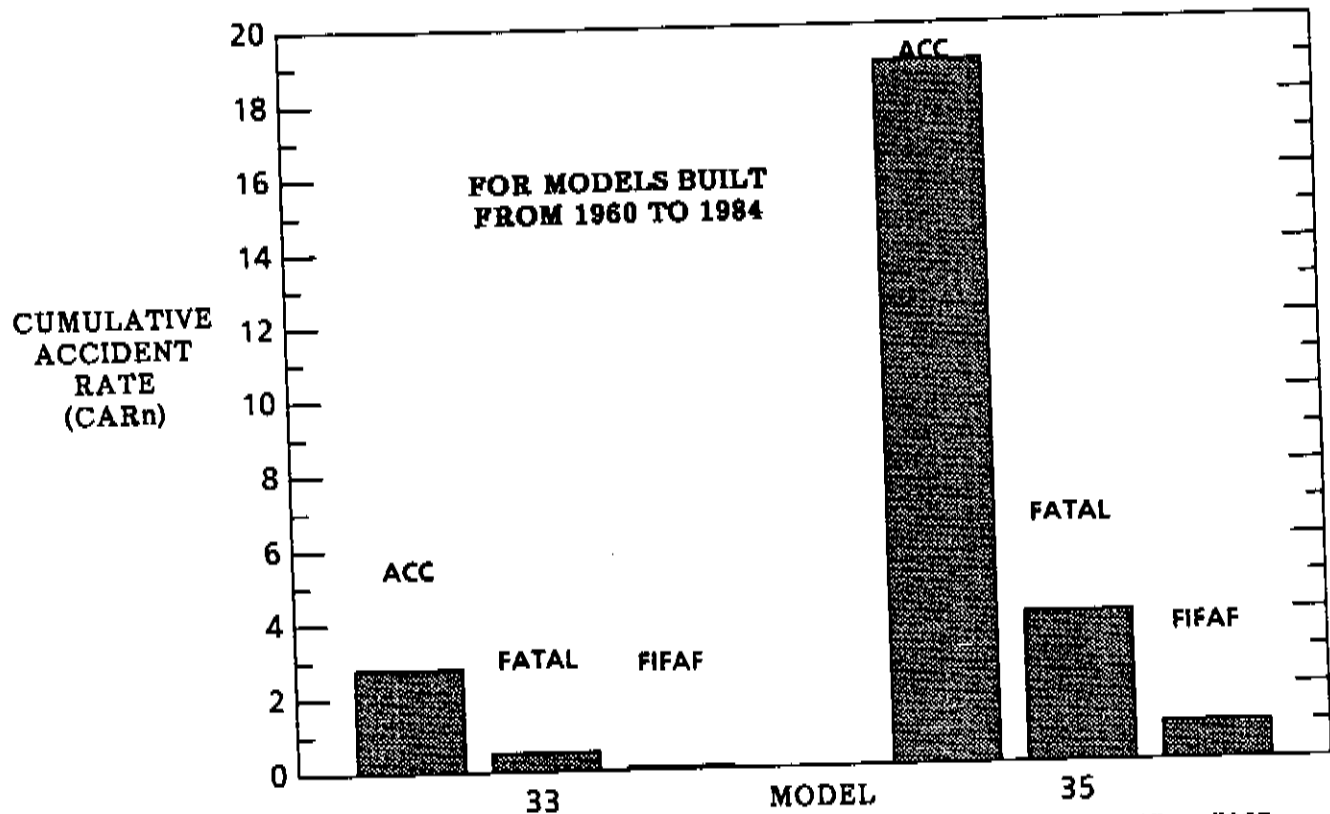
FIGURE 6-9. ACCIDENT RATE COMPARISON: MODEL "33" vs "35"

Summaries of the accident data for the V-tail and Model 33 are displayed in Table 6-11. The cumulative accident rates, as defined in Equation 6-1, are used to compare the records with bar charts in Figure 6-9. This graph clearly shows that the V-tail's overall accident rate and fatal accident rate as well as the FIFAF accident rate are significantly greater than for the Model 33. After 25 years, the V-tail Bonanza with 19 accidents per 1000 aircraft years of exposure had a rate seven times as high as the Model 33 which had a rate of 2.8 accidents per 1000 aircraft years.

The comparison of fatal accidents is made for all fatal accidents other than the FIFAF category. On this basis, the fatal accident rate comparison is similar, with the V-tail having a rate 6.5 times as high as the Model 33 after 25 years. The V-tail had 3.7 fatal accidents per 1000 aircraft years while the Model 33 had 0.6 fatal accidents per 1000 aircraft years.

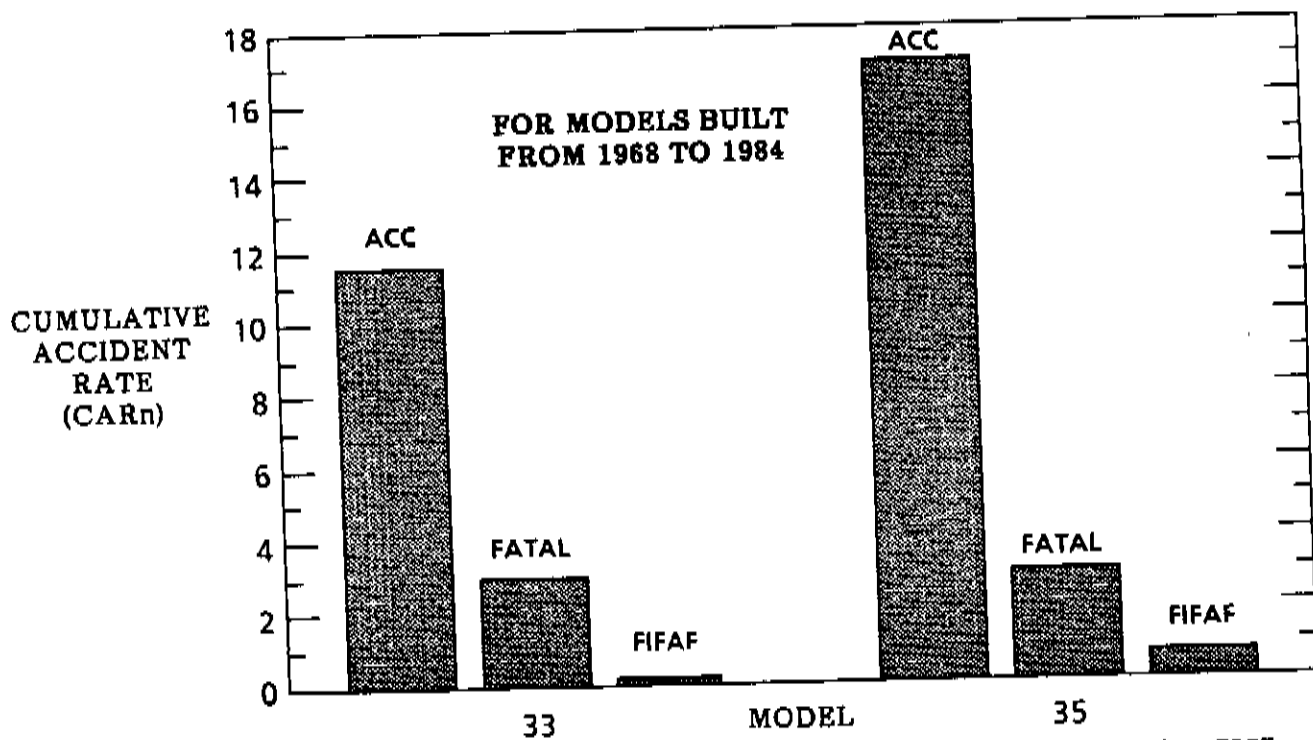
FIGURE 6-10. ACCIDENT RATE COMPARISON: MODEL "36" vs "35"

The record of the Model 36 is not as outstanding as that for the Model 33. For accidents and fatal accidents other than airframe failures, it is very similar to that of the Model 35. The data for this comparison is presented in Table 6-12 and the accident rates for the seventeen year period are displayed on the bar graph in Figure 6-10. For this comparison, the V-tail total accident rate is 1.4 times as high as the Model 36 and the fatal accident rate excluding FIFAF accidents is the same.

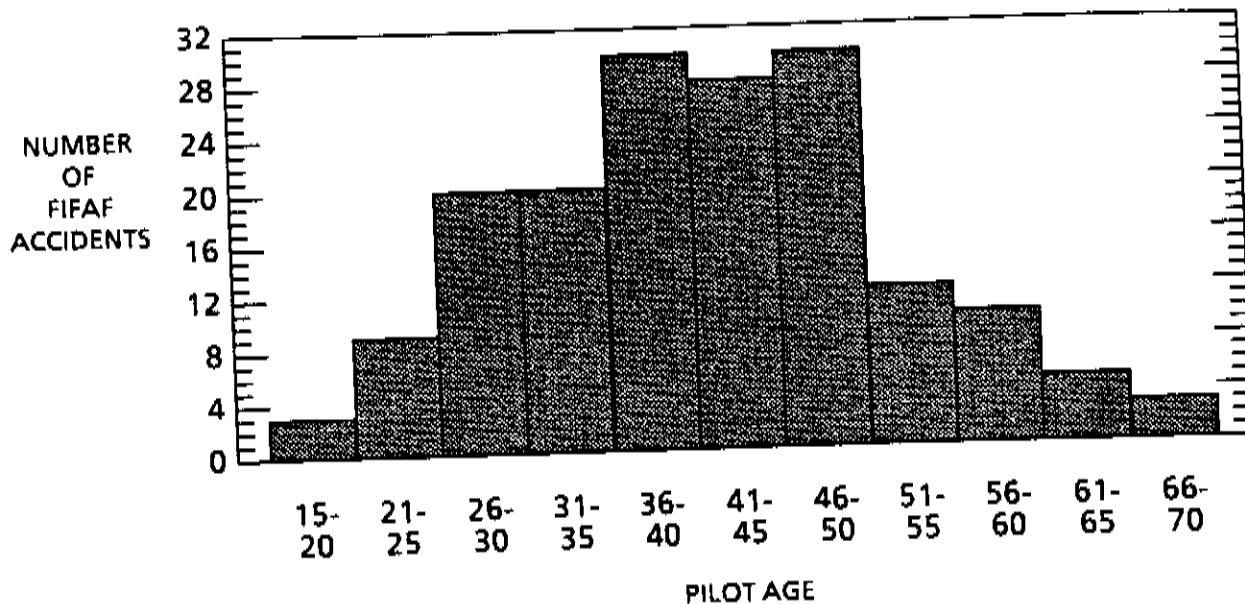
FIGURE 6-11. FIFAF ACCIDENT DISTRIBUTION BY PILOT AGE

Pilot age and experience were also examined and the results are found in Figure 6-11 and Table 6-14. The distribution of accidents relative to the pilot's age is basically bell shaped with the 36-40 and 46-50 categories highest with 30 accidents each. Eighty-eight of the FIFAF accidents are distributed in the age bracket from 36-50, and only thirty of the pilots were older than fifty. The average age of the pilots for the 167 accidents in which information was available was 42. Experience of the pilots (both total and in-type flight hours) was examined and the results are also shown in Table 6-14. Only 17.2 percent of the pilots had less than 250 total flight hours and over 54 percent had more than 500. FIFAF accidents cost the lives of 14 pilots with experience in excess of 5000 flight hours. In-type experience is significantly different with 75.3 percent of all FIFAF accidents involved pilots with less than 250 hours of experience with the V-tail. Another 10.3 percent of the accidents involved pilots with 251 to 500 hours of experience and the remaining 14.4 percent of the accidents happened with pilots who had between 501 to 3000 hours of experience in-type.
